MOSS NO. 2

RUSSELL COUNTY, VIRGINIA

Inventory Number: VA. NO. 16705

PHASE I INSPECTION REPORT

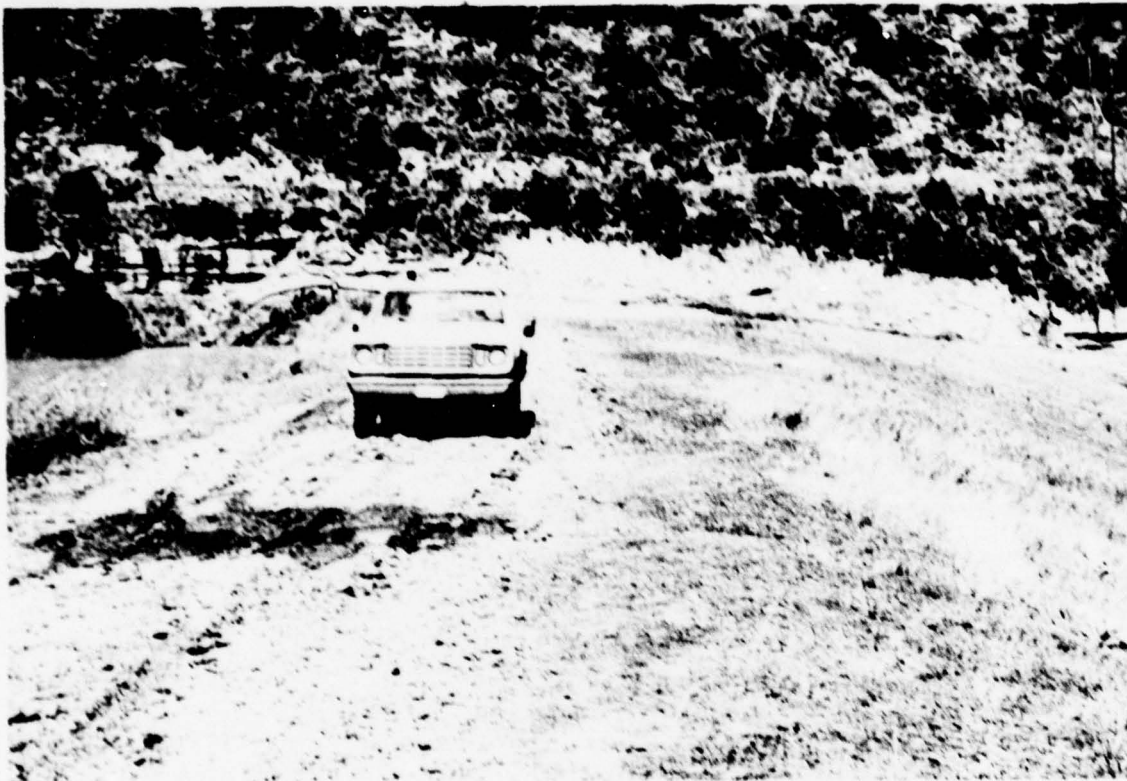
OVERVIEW PHOTO

(Note: Vertical wall in background is
Typical of slope found around
reservoir.)

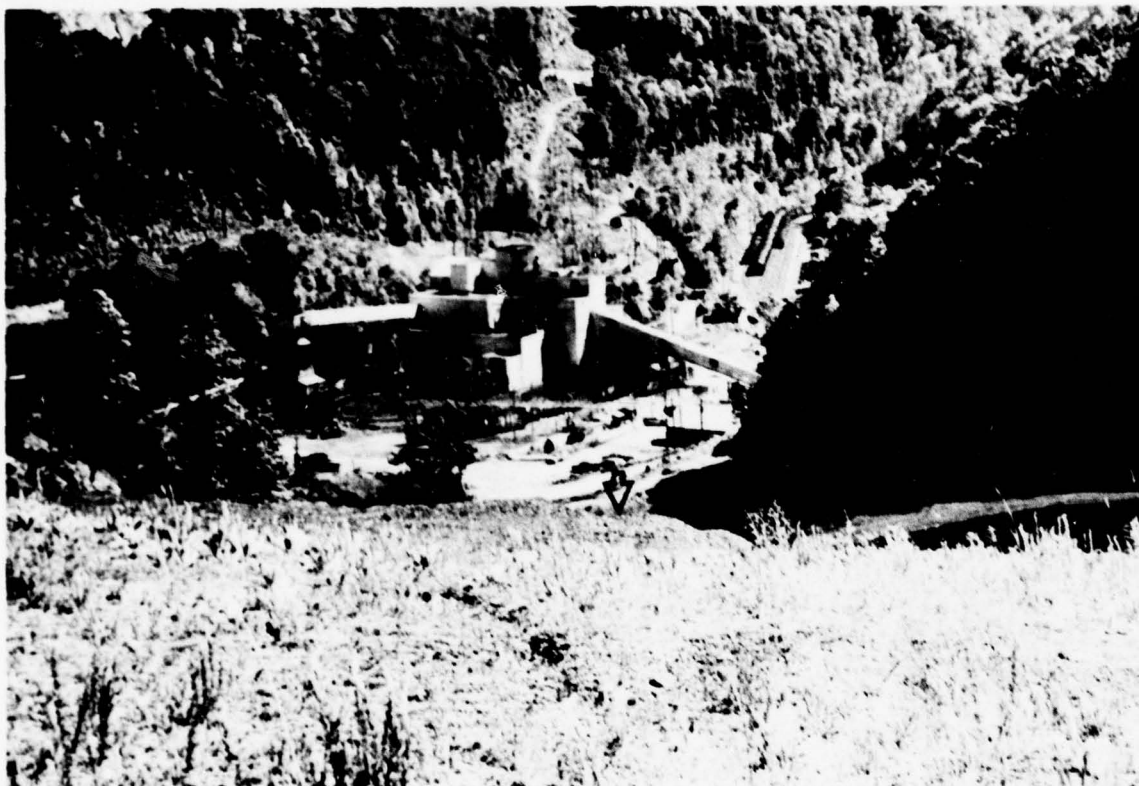
VIEW FROM TOP OF DAM LOOKING DOWNSTREAM AT TOE OF DAM AND
MINING OPERATION IN VALLEY BELOW IMPOUNDMENT. (ARROWS DENOTE
BOTH SPILLWAY LOCATIONS)

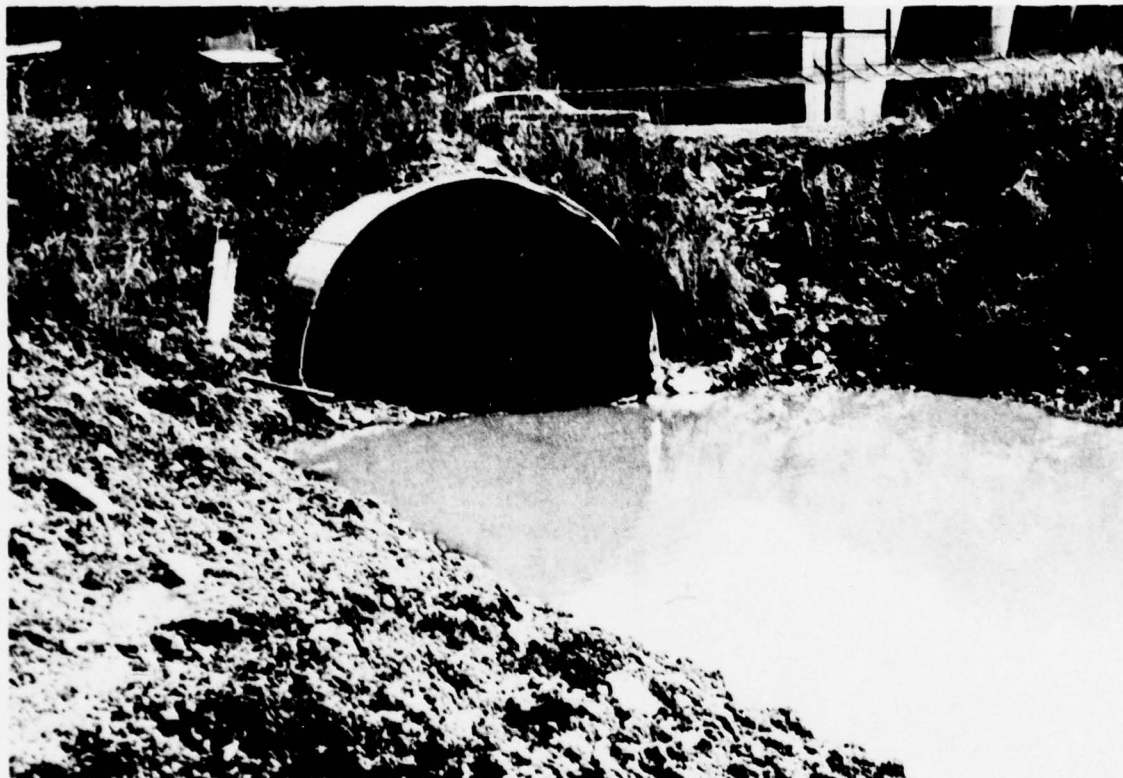
3.1.4 Downstream Area: The stilling basin appeared to be operating properly. Discharge is through an 8 ft 3 inch x 12 ft 6 inch corrugated metal arch pipe under Va. Route 621 at the toe of the embankment. The arch pipe is in good condition with no corrosion or collection of debris. At the outlet of the arch pipe is a broad floodplain in which a coal loading and washing operation is located.

VIEW OF STILLING BASIN AND CMP WHICH DISCHARGES
UNDER ROADWAY

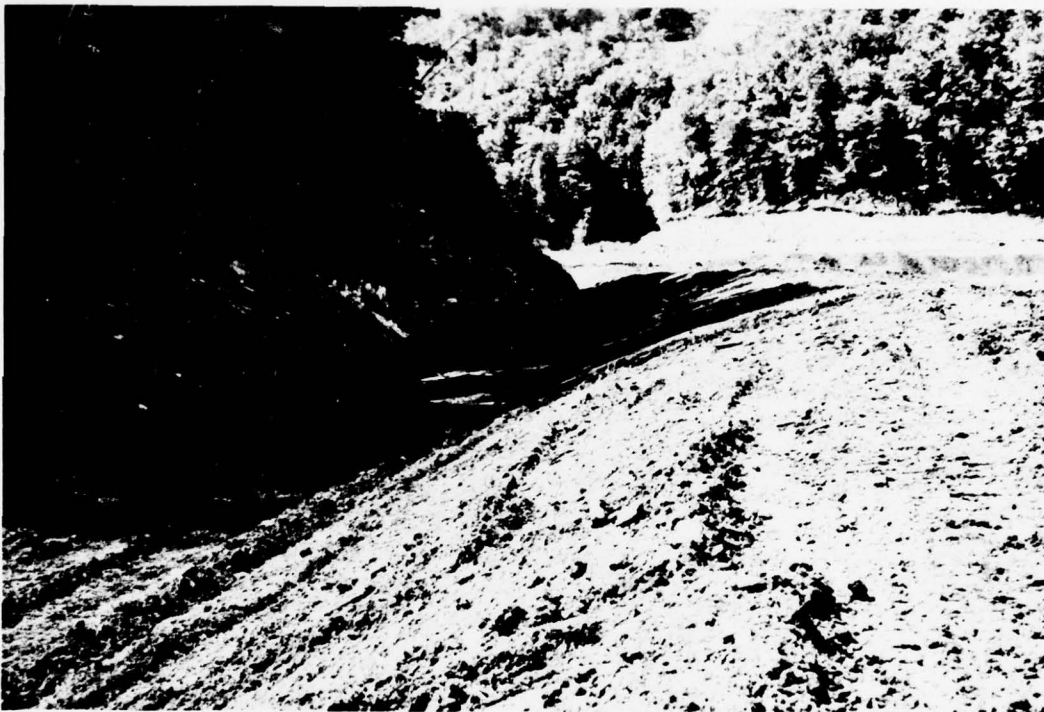
NEW DIVERSION CHANNEL BEING CUT INTO THE RIGHT ABUTMENT
(LOCATION IS BETWEEN CONCRETE SPILLWAY AND RIGHT
ABUTMENT)

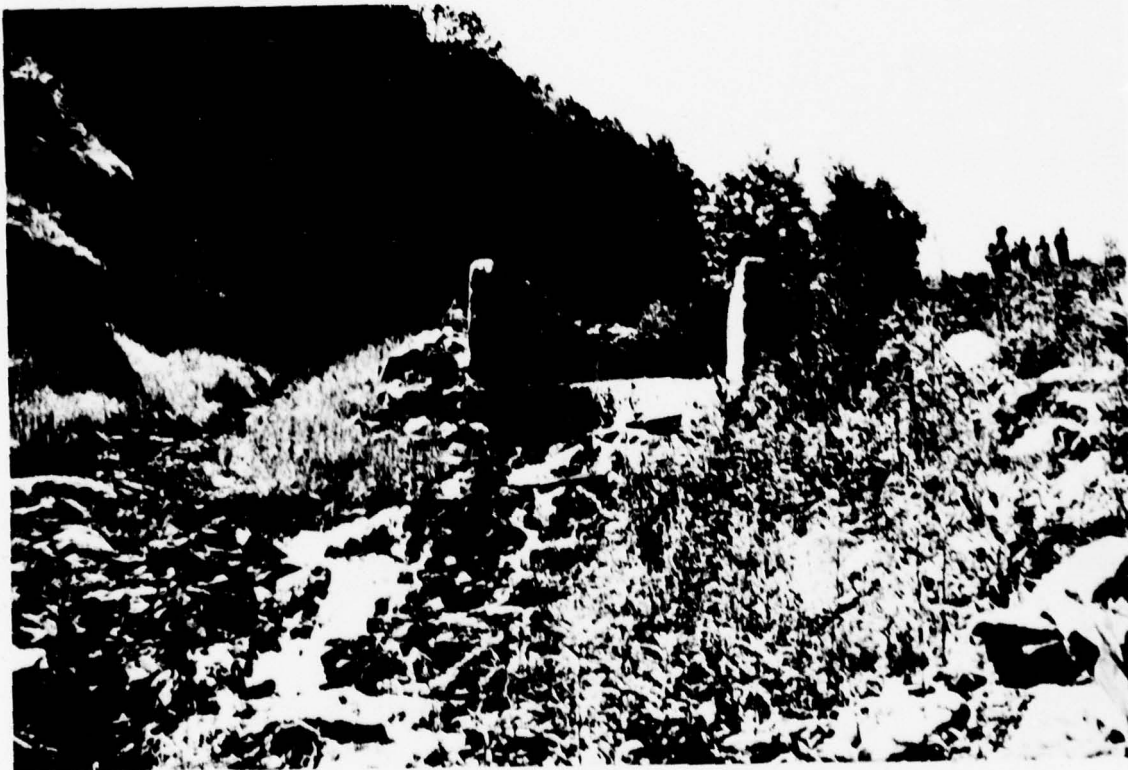
impoundment and is considered to be a spring. Erosion observed along the right downstream embankment-abutment junction is the result of surface runoff and discharge from the spillway. (See Photo 5, Appendix II).

DISCHARGE END OF CONCRETE SPILLWAY (FROM THIS POINT
WATER DISCHARGES DOWN EMBANKMENT AT JUNCTION WITH
RIGHT ABUTMENT, OVER RIPRAP, AND NATURAL ROCK INTO
STILLING BASIN)

7.2.1 The erosion at the principal spillway should be repaired.

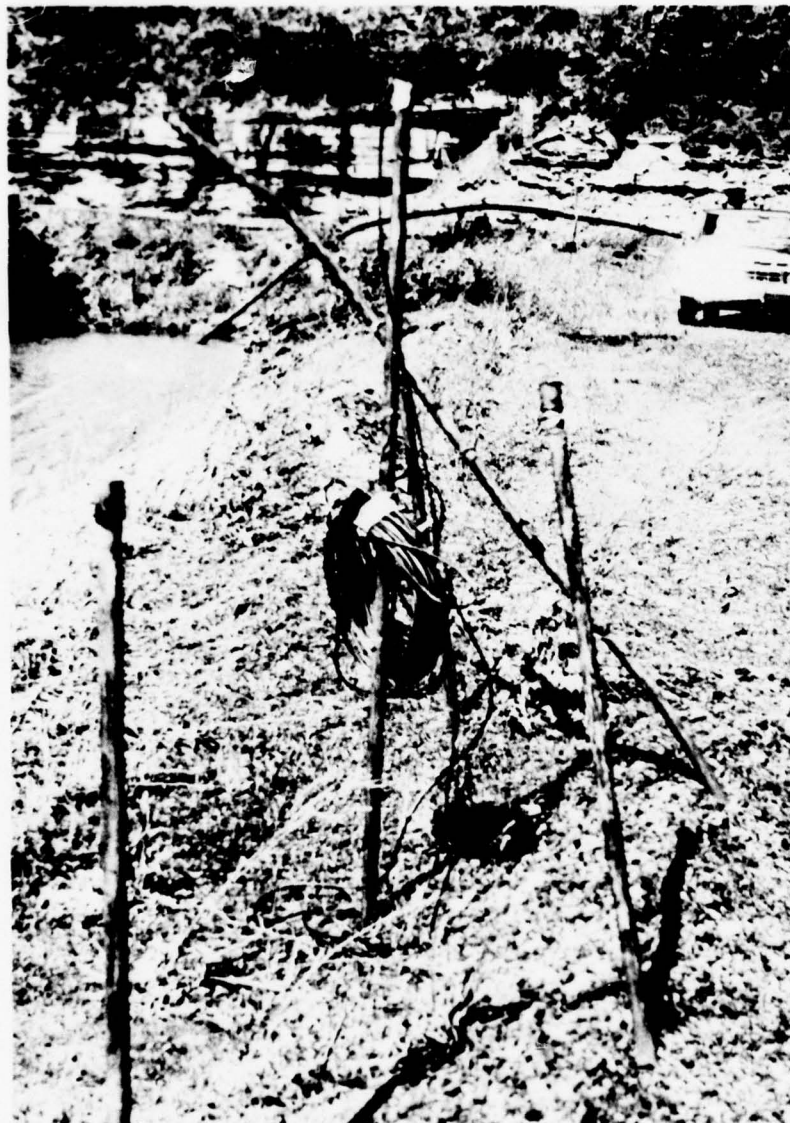
PIEZOMETERS LOCATED ALONG TOP OF DAM

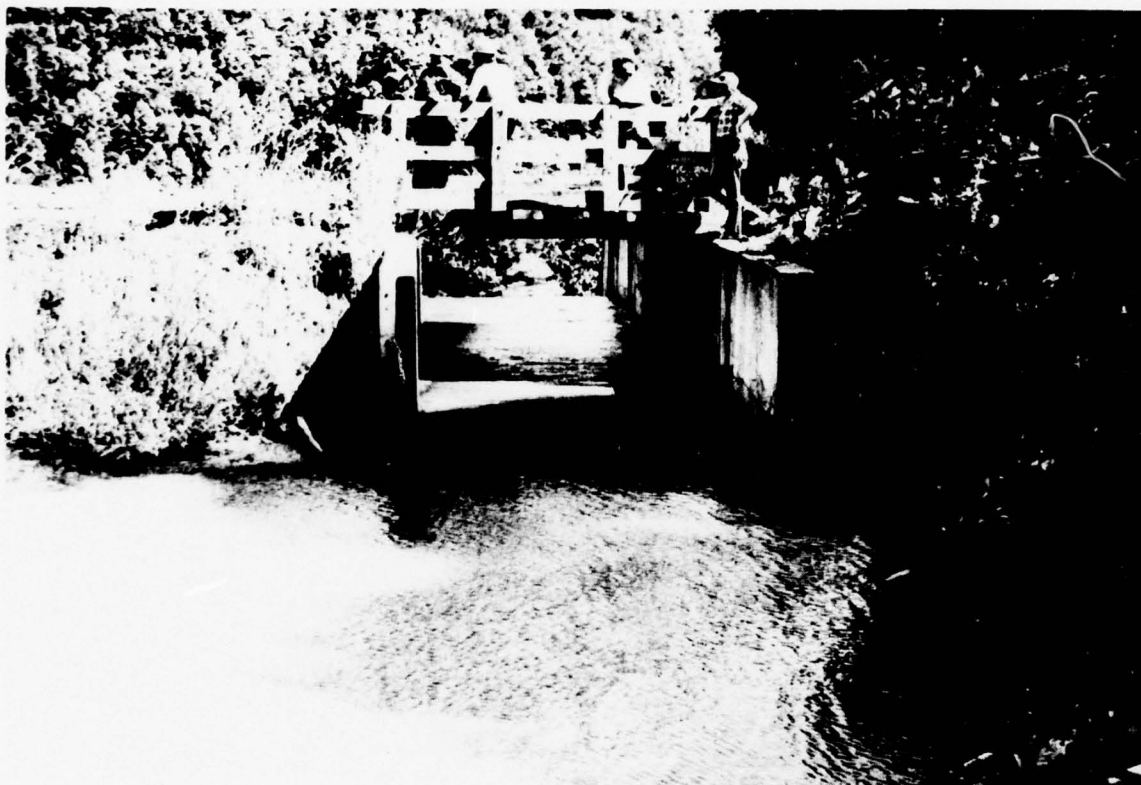
CONCRETE SPILLWAY CHANNEL, WEIR AND APPROACH CHANNEL
WITH NORMAL FLOW DEPTH

2.2 Outlet Structure: Channel showed spalling of concrete.

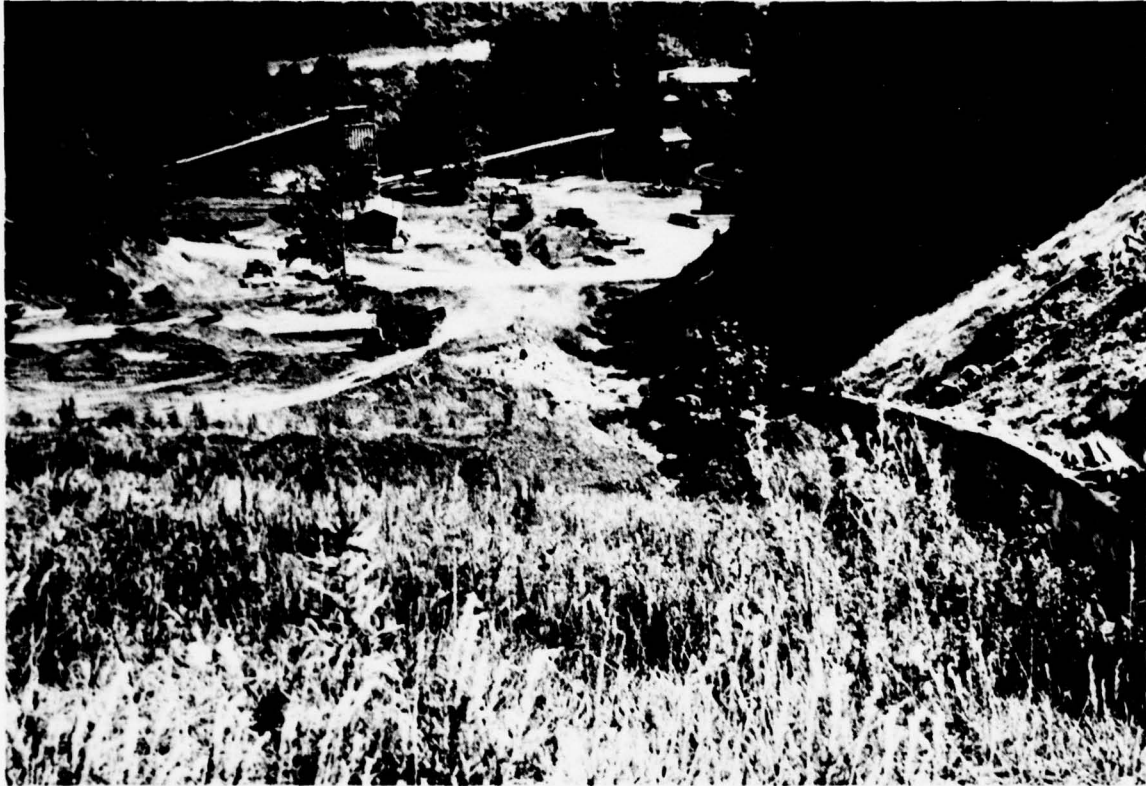
VIEW OF THE END OF CONCRETE SPILLWAY (ARROW)
AND DISCHARGE CHANNEL TO STILLING BASIN
